## BUILDING INSPECTION REPORT CONCORD STATION CLUBHOUSE – LAND O’ LAKES, FLORIDA

On June 24, 2016, RGA-Design conducted a building inspection of the Concord Station Clubhouse, located at 18636 Mentmore Blvd, Land O’ Lakes, Florida 34638. The existing conditions of the structural, mechanical, electrical and plumbing components, where accessible, were inspected.

## Confidential Inspection Report

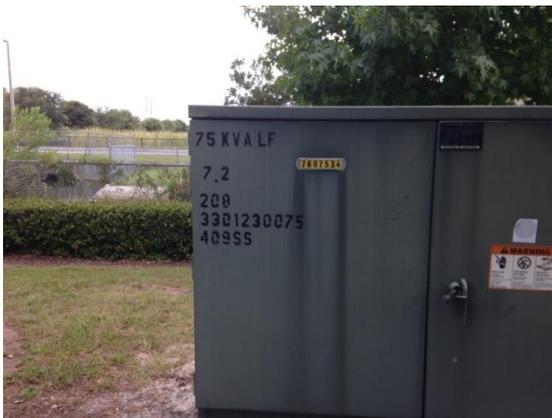
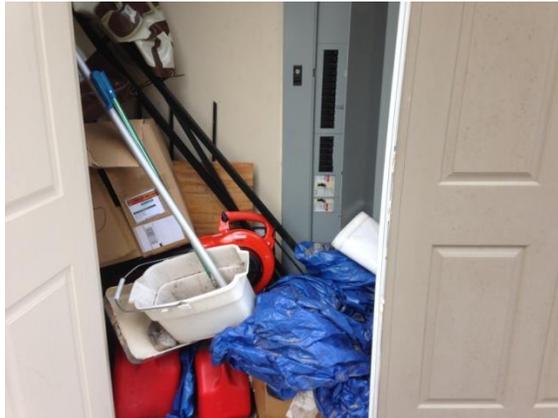
The electrical system is 120/208 3 phase provided from a utility pad mounted transformer located on the east side of the property. The building is provided with a 400 amp main distribution panel located in an electric/storage room accessible from the exterior only.

The electric panel access is blocked by lawn equipment and gas containers. This is a fire and safety violation.

X     Comments: REMOVE ITEMS TO PROVIDE CLEAR ACCESS.

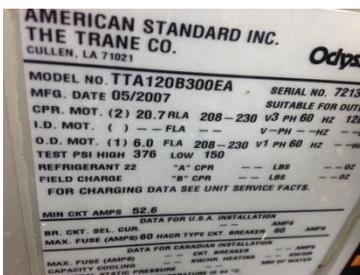
Unit 3 (10 ton)

There are three A/C units serving the building, one 10 ton and two 5 ton units. All units were manufactured by Trane Corporation in 2007. The units appear to be well serviced and operating properly. The typical life expectancy of similar units is 10 to 15 years.

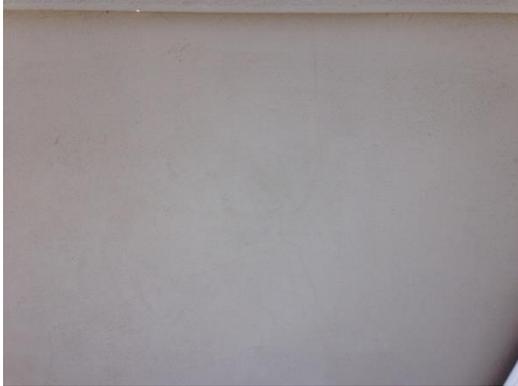
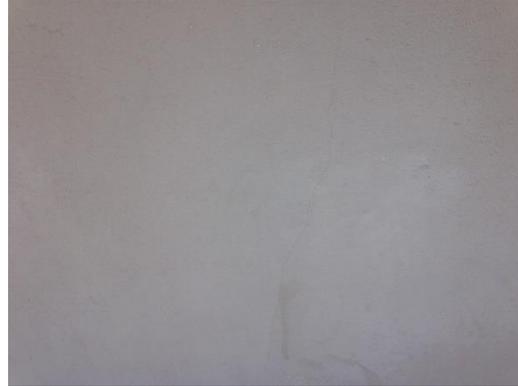
With any structure built in Pasco County, differential settlement (sinkhole activity) is always a concern. Conscious of this, I was especially observant for stair step cracks in the block walls, out of square/plumb windows and doors, masonry cracks around windows and doors, etc. No stair stepping was observed.

What appears to be drying cracks in the stucco finish were noted on the SE side of the structure.

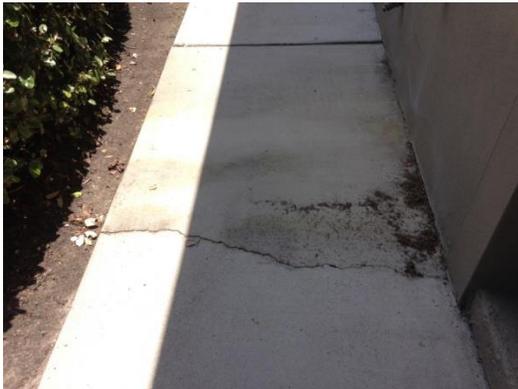
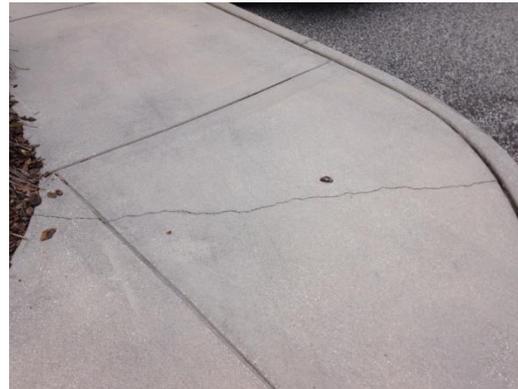
The cracking is minor and difficult to see in the wall finish. In my opinion, the cracks above are NOT indicative of structural failure, nor differential settlement.

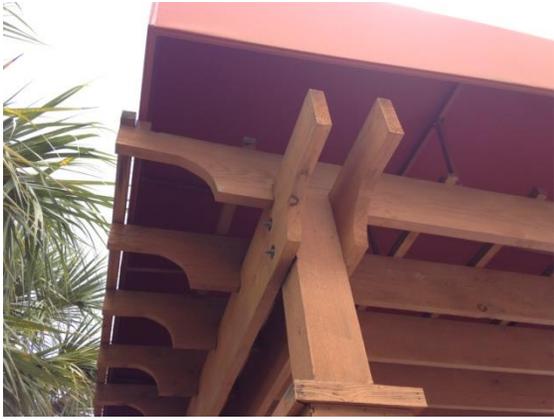
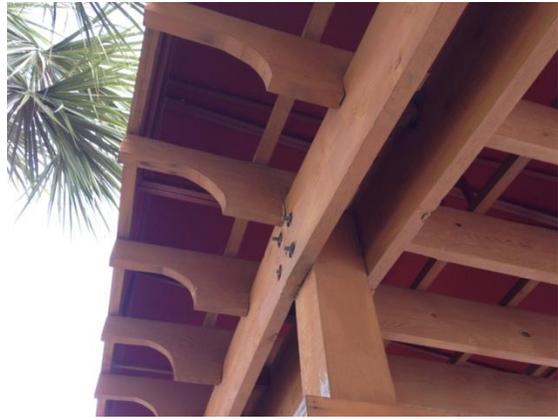
A wood pergola structure is located adjacent to the pool. A metal frame awning covers the pergola. The attachment of the awning to the pergola could not be determined. The pergola structure does not have metal straps/clips securing the rafter members against storm force winds.
